Composite Overwrapped Pressure Vessels (COPV) Materials Aging Issues

Materials Science and Technology 2010
October 20, 2010
Houston, Texas

Rick Russell
Materials and Processes Engineer
Materials Science Division, NE-L4
Kennedy Space Center, Florida

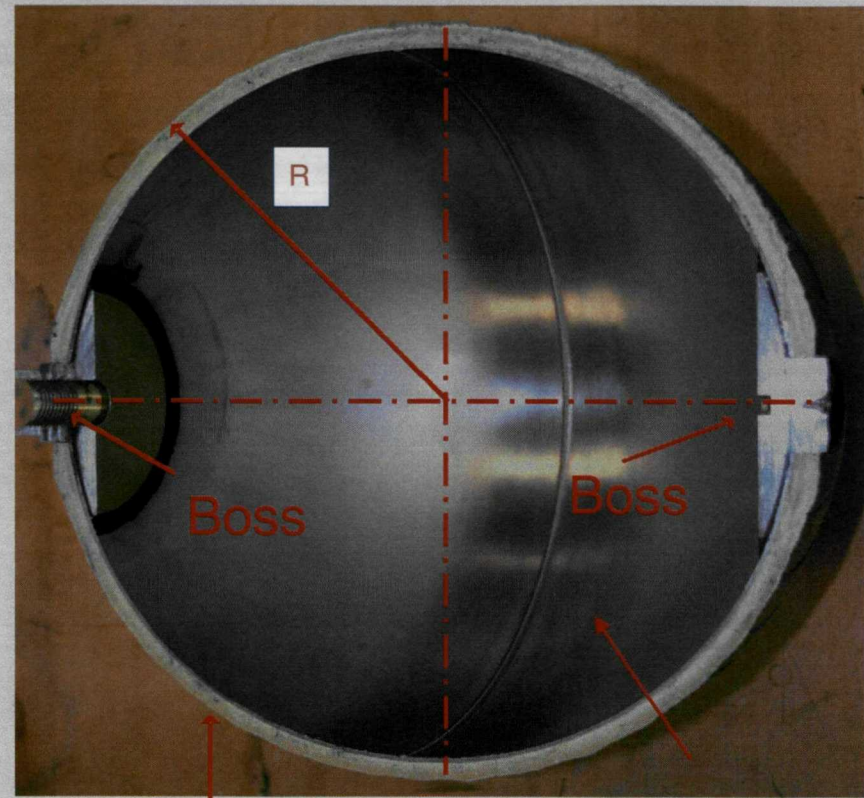
- NASA Orbiter Pressure Vessel
- Need was a light weight high strength pressure vessel
- NASA COPV was designed in 1970's
- Basic Composition:
 - Boss
 - Composite Overwrap
 - Metallic Liner
- Safety is key factor

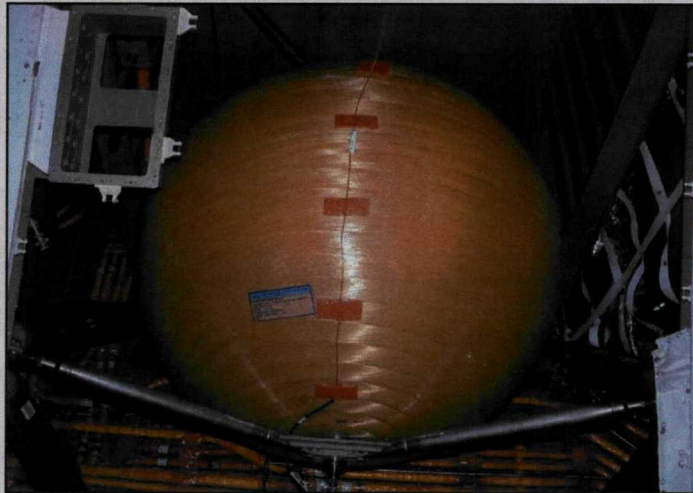
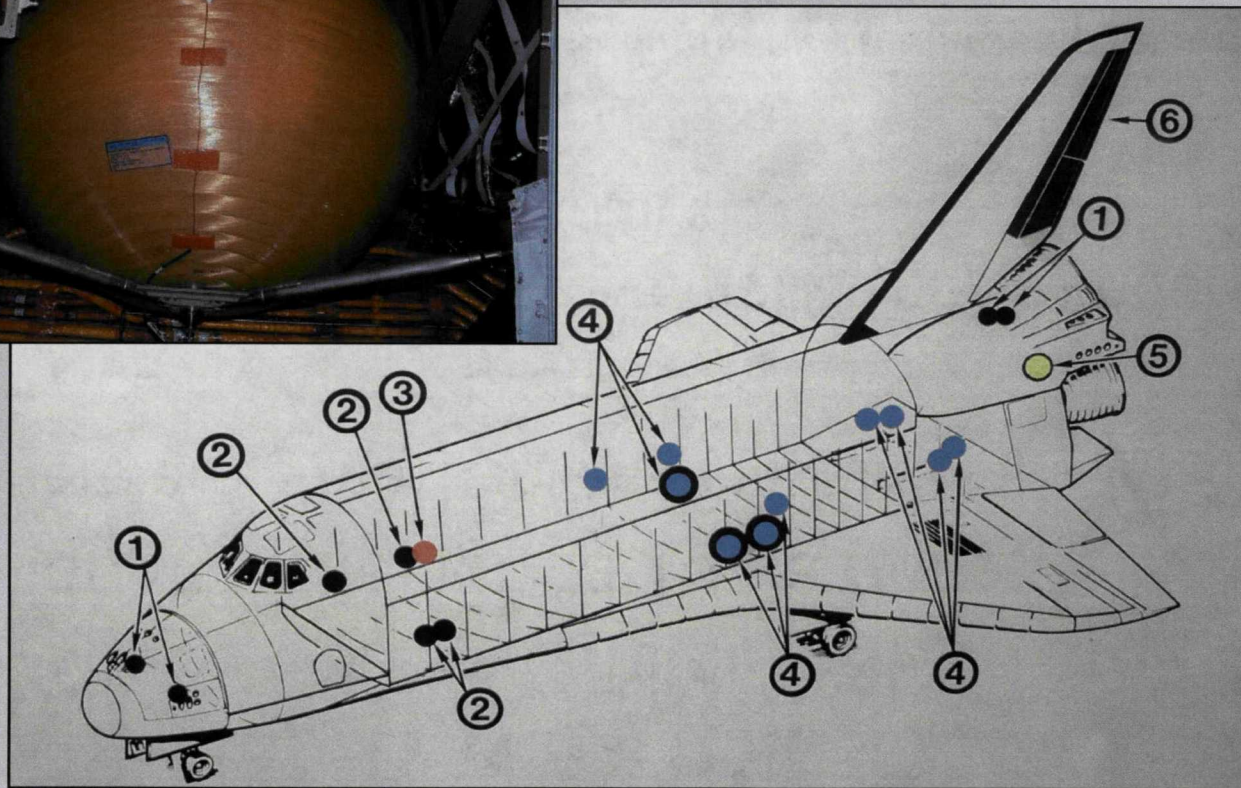
Composite Overwrap

Metallic Liner

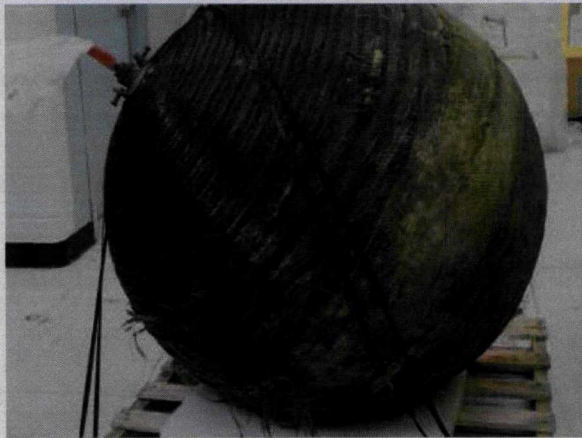
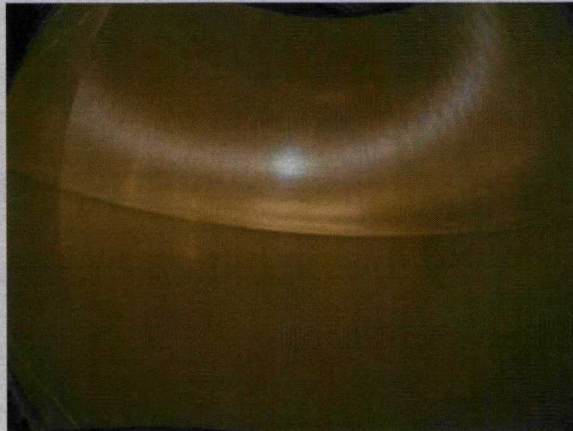
S/N 29 - Columbia vessel

- 25 years old
- Survived reentry
- Interior provided good samples

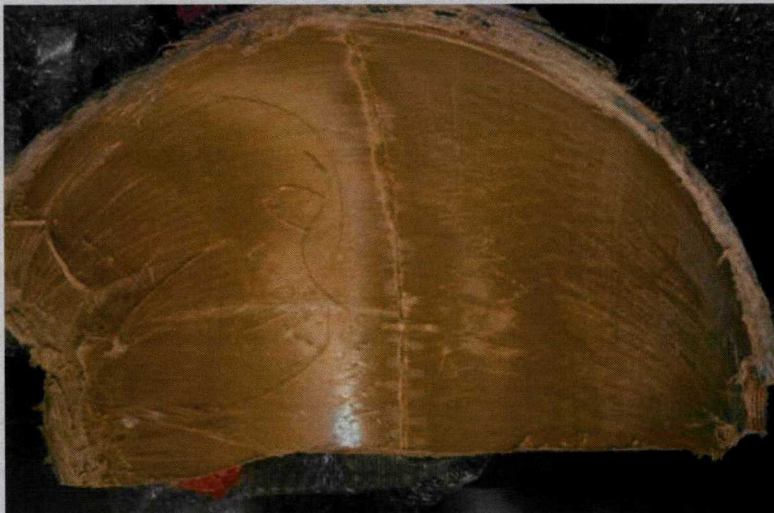
S/N 11

- 25 years old
- Not exposed to space
- Extensive pressure cycling

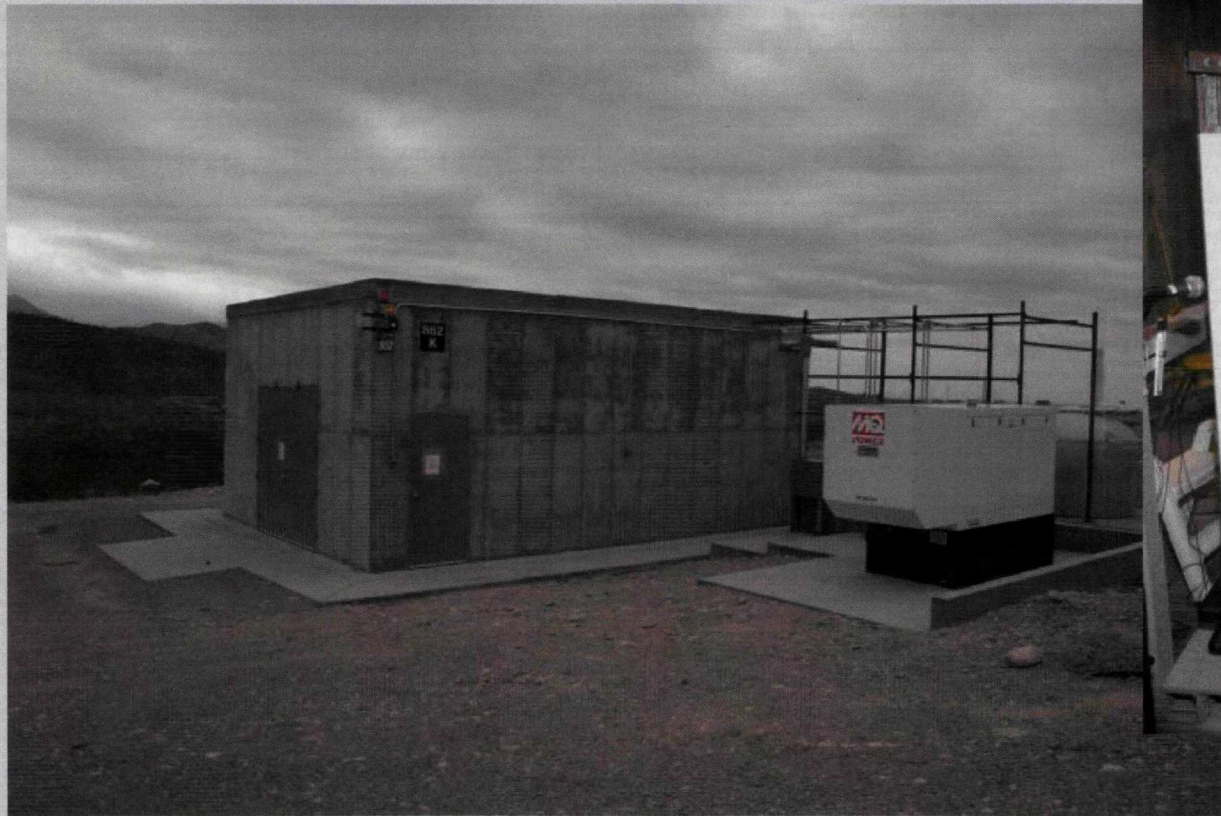
WSTF Test Cell, thermally controlled test cell with generator back-up. Precludes thermal control concerns akin to those of the LLNL tests.

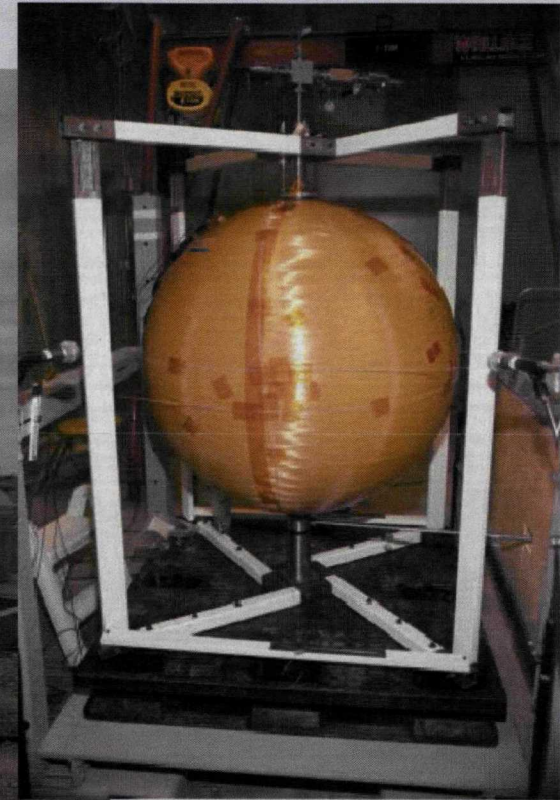
OMS/MPS test article in test frame. Allows freedom of movement to monitor vessel dimensional changes during test.

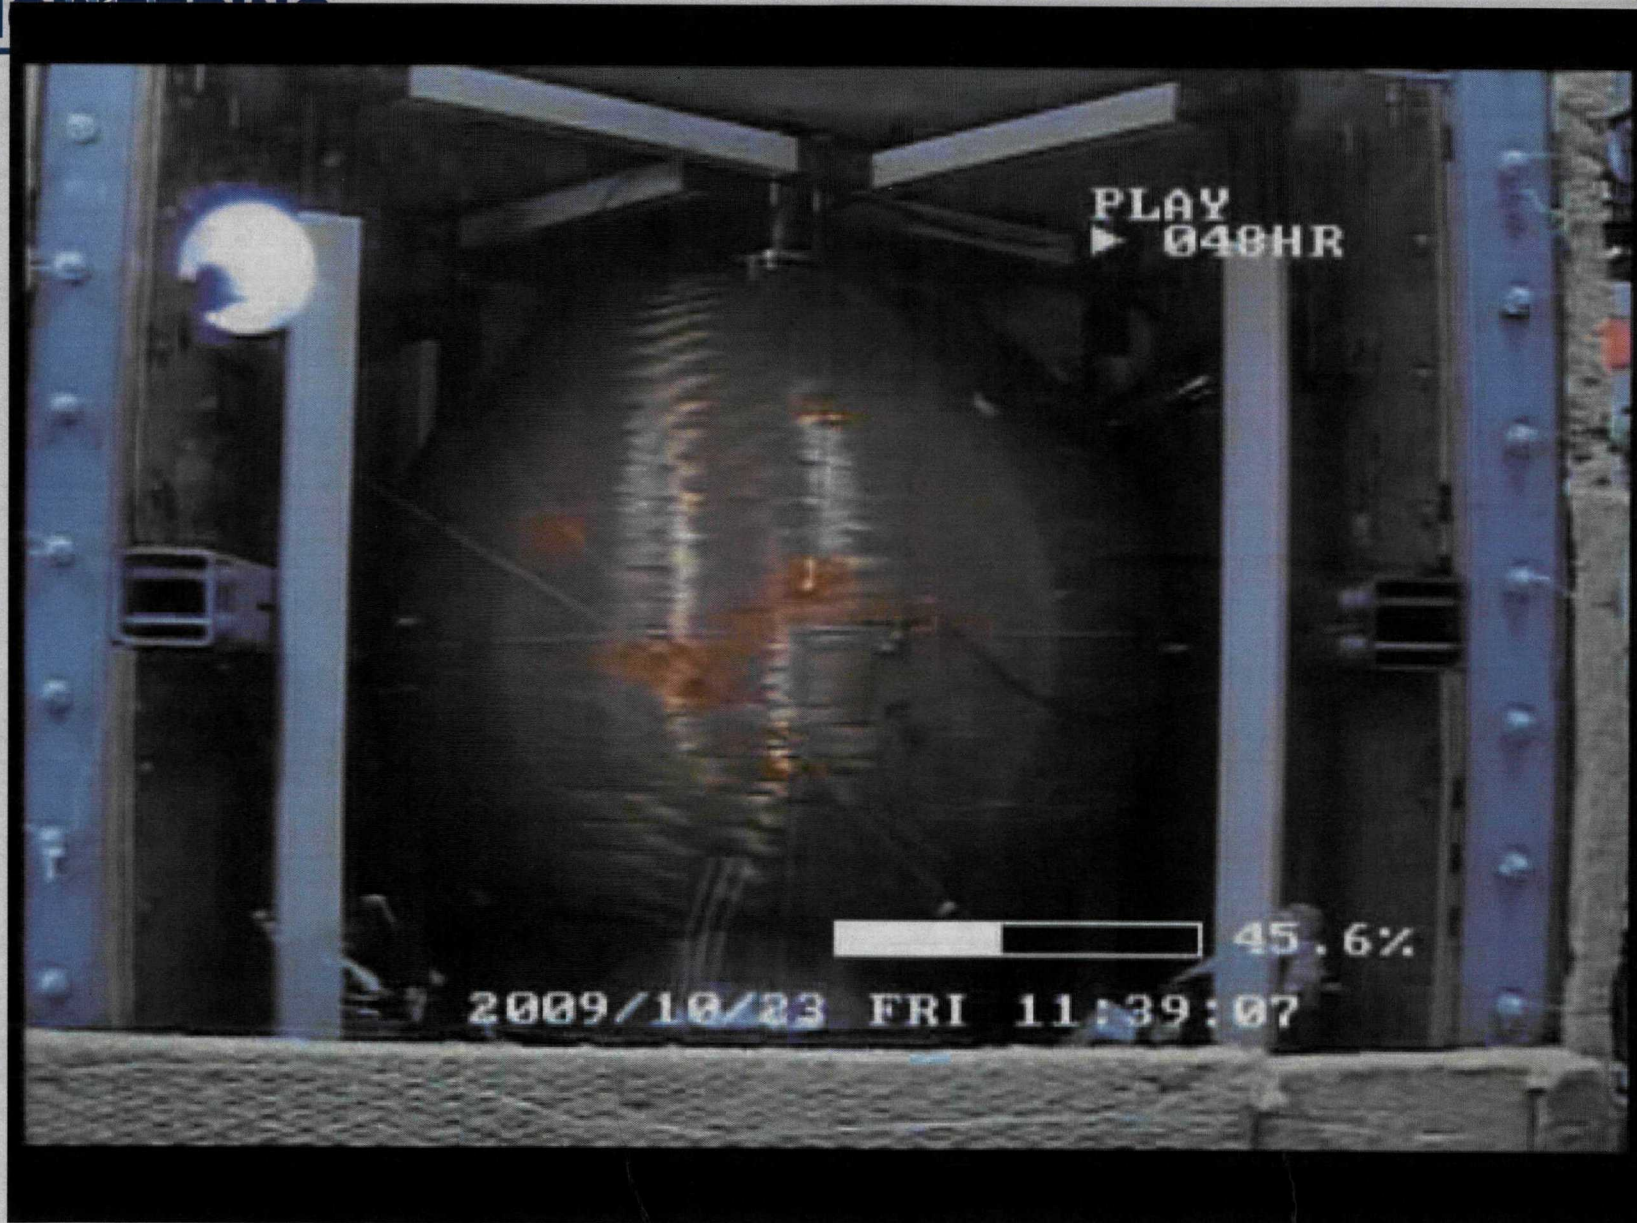
Test Results

- Pressure: 5400 psi
- Temperature: 174°F
- Result: Tank failed after 3,100,000 effective hours
